# Sudden degradation of asphalt road mixes during periods of freeze-thaw events: Analysis of field cases and exploratory laboratory research

## ■ ABSTRACT

## BACKGROUND

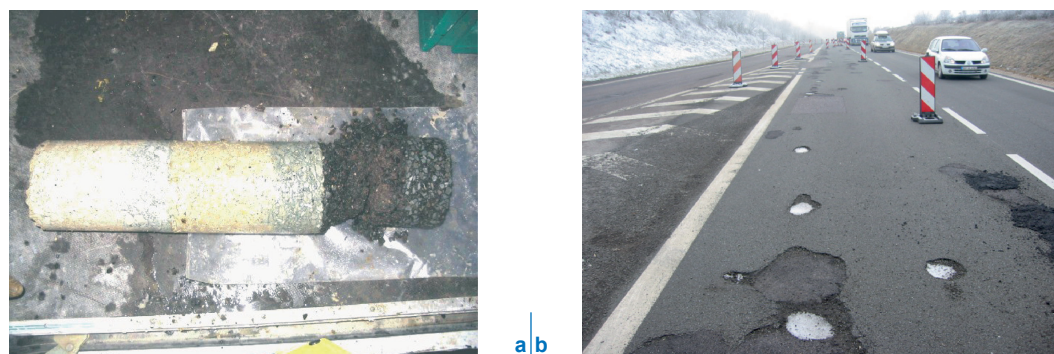
During the winter season 2005/2006, within just a few days, many potholes appeared over the first kilometre of the section (see Fig. 1), requiring emergency repairs, several times a day in some places. These potholes, of a size in the tens of square cm and 5 to 12 cm deep, are plentiful, tightly spaced from one to the next and located in their entirety on the slow-traffic lane, predominantly in the wheel tracks. The borehole samples extracted on this portion of pavement, following these events, reveal that the foundation treated with a hydraulic binder remains in very good condition, with a thin AC bonded to it. The cracked and crazed wearing course lies on two non-cohesive layers, with the presence of hydrocarbon materials that display considerable stripping.

**Figure 1**  
*Pavement disorders in north-eastern France*  
 (a) Pavement structure borehole sample  
 (b) Pattern of potholes tens of cm in size

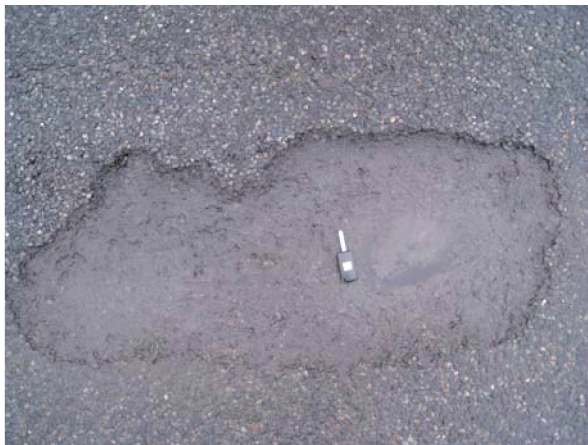
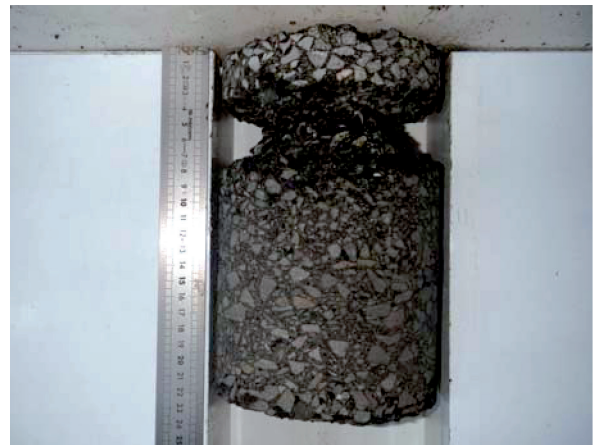
At the end of January 2010, potholes were forming within a very short interval, making it necessary to close the section. The dimensions of these potholes were larger than 10 square cm and their depth in some instances reached 15 cm. These flaws were observed on the wearing course in direction 2, on a length extending more than 500 m, which for the most part corresponds to the low point of the road profile. It could also be observed that the pavement structure was loaded, despite being built as an embankment, since the potholes were filling within a few minutes when empty (Fig. 2a). The onsite borehole coring campaign displayed disaggregation of the asphalt concrete at the level of the first interface (Fig. 4b), in this case at a depth of several cm.

**Figure 2**  
Observations recorded on test section 2 (central France specimen)  
(a) Rise of a head of water in a pothole in the PA layer  
(b) Borehole sample with disaggregated PA

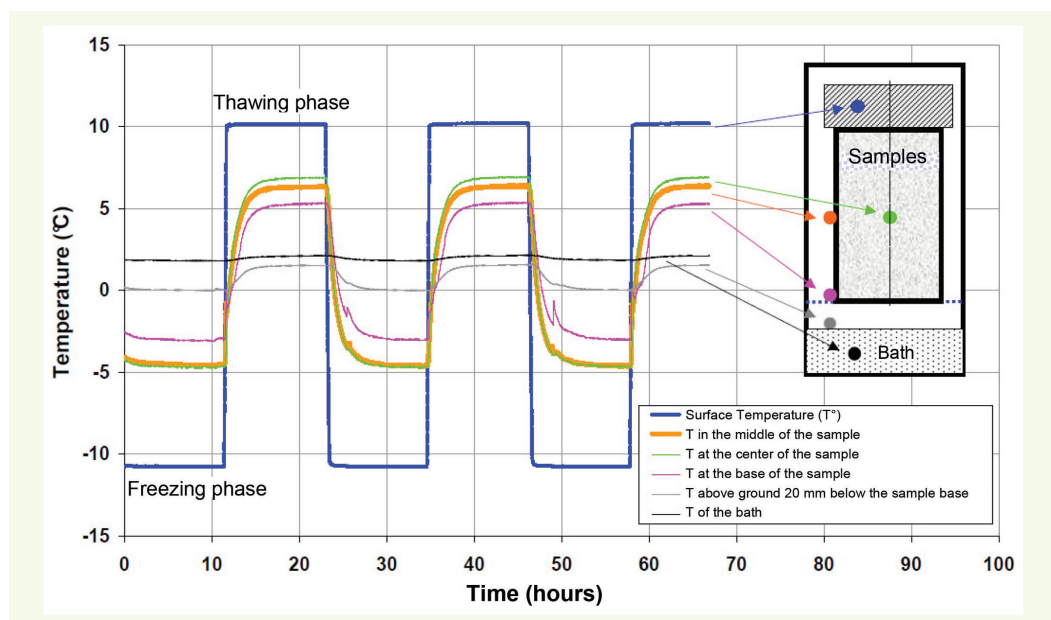
Preliminary tests were conducted for the purpose of determining the temperatures obtained at the sample core when freeze-thaw cycles are applied at the surface. The objective herein consisted of defining a sufficient cold intensity and cycle duration that allow reaching negative temperatures at the core and hence avoid supercooling phenomena. **Figure 11** highlights the temperature variations

**Figure 11**  
Temperature acquisition at various specimen levels during the freeze-thaw test

at different specimen levels during the 24-hour application period of a  $+10^{\circ}/-10^{\circ}\text{C}$  cycle at the surface. The extreme temperatures identified are as follows:  $+6.5^{\circ}/-4.5^{\circ}\text{C}$  at specimen mid-height,  $+5^{\circ}/-3^{\circ}\text{C}$  at the base, and  $0^{\circ}/1.8^{\circ}\text{C}$  aboveground 20 mm below the specimen base. The variations of this last sensor are very small due to the influence of bath temperature, which has been set at  $2^{\circ}\text{C}$   $0.5^{\circ}\text{C}$  for the test duration. The instrumentation layout thus produces a non-homogeneous vertical thermal gradient within the specimen.

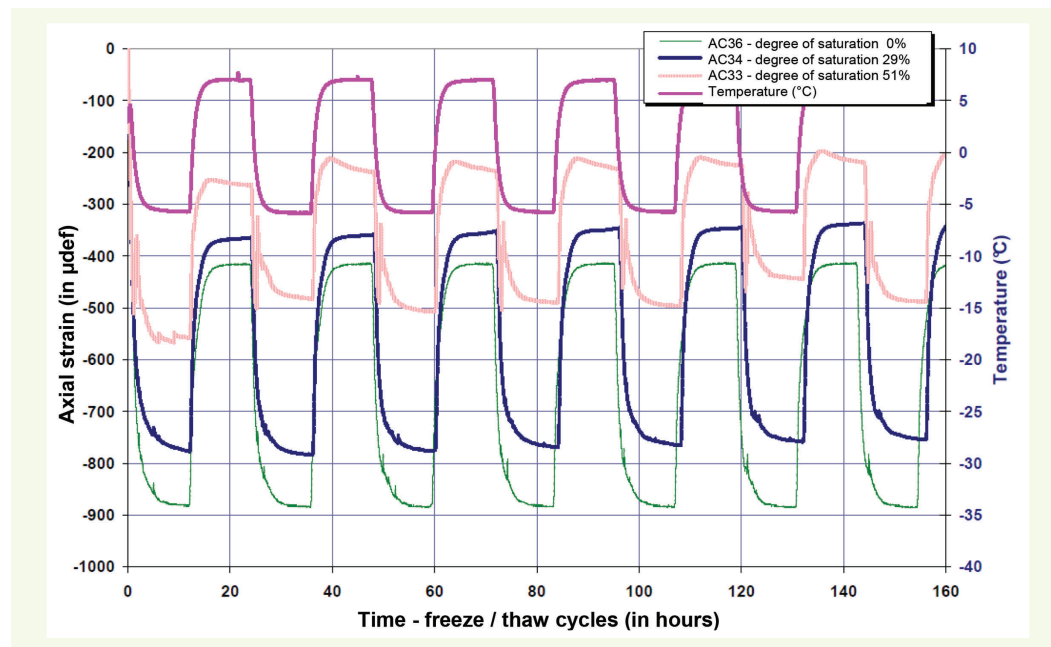
The temperature at specimen mid-height, considered as the average specimen and gauge temperature, is represented in **Figure 13** (upper curve, right-hand scale).

**Figure 13**  
Evolution of both temperature and strain vs. the number of thermal cycles

This figure compares the thermal strains of all three specimens at different degrees of saturation, vs. the number of freeze-thaw cycles. The thermal strain has been arbitrarily set to zero at the initial test temperature +10°C.

When the test is conducted on the sample with limited water saturation (i.e. AC-34), the coefficient  $\alpha_m$  decreases slightly to a value of  $30 \cdot 10^{-6} \text{ K}^{-1}$ . When the degree of saturation reaches 51% (AC-33), the (apparent) coefficient  $\alpha_m$ , as measured over this same temperature interval, drops more abruptly to a value of  $23 \cdot 10^{-6} \text{ K}^{-1}$ . At this point, it becomes interesting to examine in greater detail the trend in strains at the scale of a single cycle.

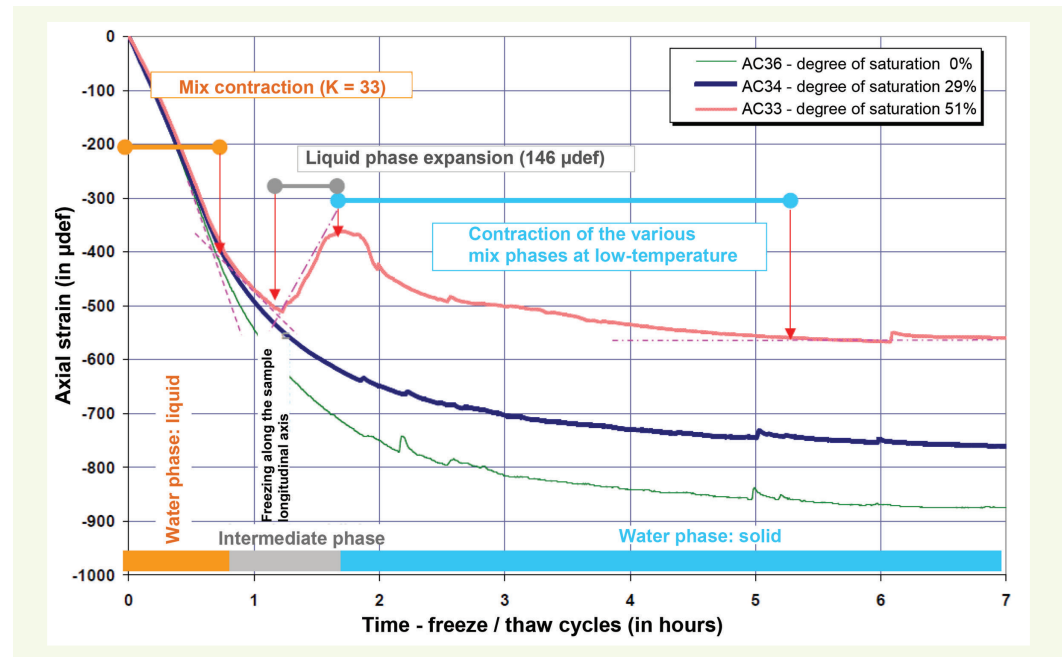
These curves are described in detail in **Figure 14**; they represent the trend in strains recorded on each sample throughout the first seven hours of the first cycle, during which time the temperature is monotone decreasing.

**Figure 14**  
Effect of degree of saturation on sample contraction and dilatation

Let's note the very sharp difference in behaviour between samples AC-33 and AC-36. The dry sample AC-36 undergoes a monotone decreasing strain that is nearly homothetic to the temperature curve, since it reaches during the thermal plateau phase a strain of approx.  $880 \mu\text{def}$ . Sample AC-33, saturated at 51%, displays a 3-stage evolution. At positive temperatures, its strain is nearly indistinguishable from that of the dry sample. During the subsequent period, as temperature drops below  $0^\circ\text{C}$ , its rate of evolution slows (in absolute value terms) until the time it quite suddenly enters a phase of significant swelling (on the order of  $150 \mu\text{def}$ ), as measured based on the concave part of the trend curve. Next, it resumes a contracting evolution that basically remains parallel to the dry sample curve. The two curves wind up being offset by a value on the order of  $300 \mu\text{def}$  (swelling + difference recorded before swelling), as reflected in the difference observed above on the average coefficients of dilatation. Sample AC-34, saturated at 29%, behaves qualitatively like the dry sample, without exhibiting any expansion when transitioning to  $0^\circ\text{C}$  temperature. The presence of water is indicated however by a slower strain rate, leading to a deviation of approx.  $100 \mu\text{def}$ .

In contrast, both before and after crossing the freezing front, the thermo-mechanical behavior of AC-33 is identical to that of a solid whose strains are proportional to the temperature variation. Moreover, the coefficients of dilatation over the course of these phases remain similar to those of the dry AC: for positive temperatures, the partial sample saturation (and free-flow conditions at the boundaries) make it possible to absorb, without inducing any effects, the sizable dilatation
